**ENGINEERING STUDY**

**PISCATAQUOG TRAILWAY PROJECT—PHASE IV  
MANCHESTER, NH**

**Federal Project No. Part of 04-33te  
NHDOT Project No. 14412**

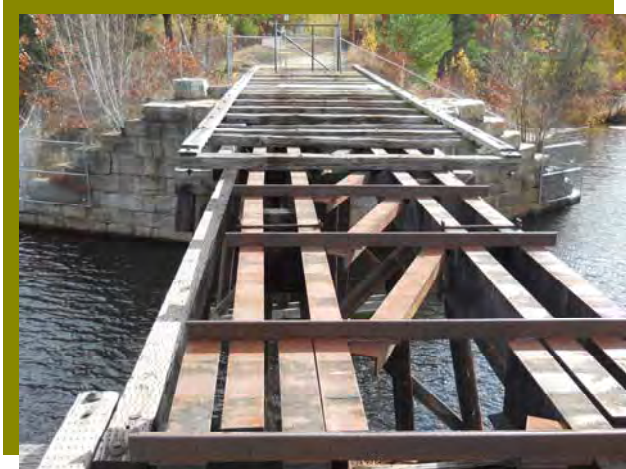
Typical Trestle Superstructure

The superstructure consists of timber cross ties bearing on 4 – 20" deep steel beams and 7 $\frac{3}{4}$ "x11 $\frac{1}{2}$ " timber beams that span longitudinally from bent to bent. The steel beams are braced extensively with steel angles that span both transversely from beam to beam and diagonally between the top flange of the center two steel beams. At each end of the cross ties, there is a timber curb. No railroad track is currently in place on the bridge.

The condition of the trestle superstructure varies from poor to good. The cross ties are in fair to poor condition with many missing near the center spans of the trestle and rot throughout many ties. The

longitudinal timber beams that flank the steel beams are in fair to good condition with the ends of several beams exhibiting twisting and rot at the ends. The steel beams are generally in good condition with little rusting or deterioration noted. The steel beams have an unknown coating that is largely intact on all surfaces except for the top flange.

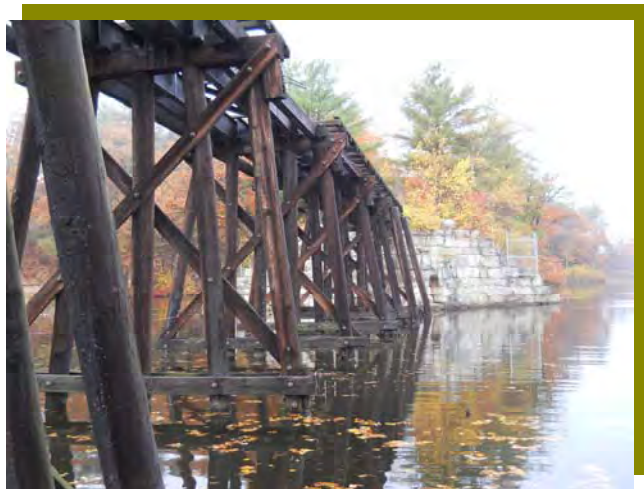
Timber Bents Looking North

The trestle bents each consist of five main piles, two of which are battered transversely to the bridge, and one upstream pile that acts as a bumper. The piles vary in diameter with an average diameter of 13" at near the waterline. The piles are capped with a 11- $\frac{3}{4}$ "x13- $\frac{1}{2}$ " pile cap that appears to be connected to the pile with a  $\frac{3}{4}$ " diameter pin, centered on the pile. The piles and cap are connected with 2- $\frac{3}{4}$ "x9- $\frac{1}{2}$ " diagonal bracing that is generally through-bolted to each pile and cap. No underwater inspections of the bents were completed as part of this study.

The condition of bents 1-5 is generally fair to good with some components in poor condition, while bent 6 (westernmost bent) is in poor condition with extensive rotting of the piles. While there are portions of each bent in poor condition, the bents are in surprisingly good condition after 70 years of service. Portions of the diagonal brace just below the waterline is broken or split at all six bents and is likely due to impact damage from ice or debris. The upstream bumper pile is missing above the waterline at bents 2-4. The cap beams for bents 3-6 all exhibit extensive rot starting from the top surface. In some locations this rot extends nearly through the entire depth of the cap beam.

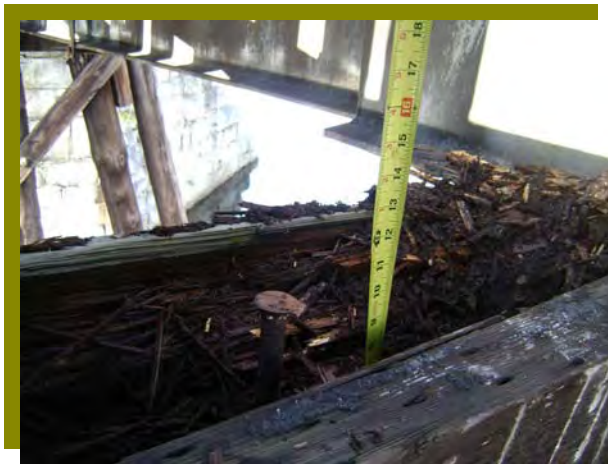
10" of Rot in 13-½" Deep Cap Beam at  
Bent 5

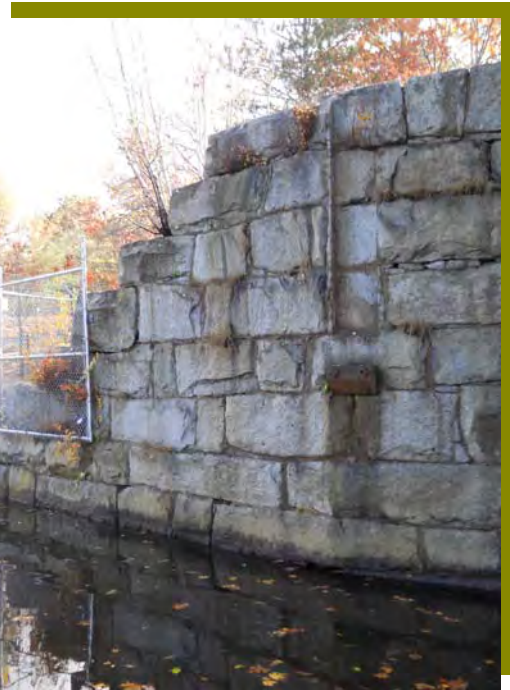
Face of West Abutment and  
Southwest Wingwall

The 16' of abutments and wingwalls visible above the waterline are in good condition with no indications of settlement, bulging or movement noted. The pointing and chinking is missing in some locations and vegetation is growing in many of the stone joints. A small tree has begun to grow at the northeast wingwall.

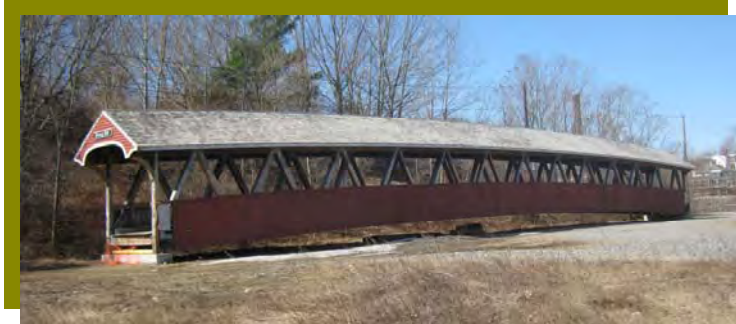
Dover Covered Bridge Elevation

The clear span between abutments at the Piscataquog River Trestle location is 151 feet 6 inches and the distance between backwalls is 169 feet 10 inches. If used in its existing configuration at the Piscataquog River crossing, the DCB would only have 8-½ inches of lower chord bearing at each end and the centerline of bearing would only be 2 inches from the face of the abutment, which is inadequate. We evaluated an option to lengthen the bridge by removing the end two lower chord sections from the existing splice to the bearing end, and replacing them with a longer section. The end two diagonal web members would also be replaced as the end diagonal would be shifted away from the center of the span, thereby increasing the center to center of bearing distance of the truss. This change does not greatly alter the truss forces and allows for the bridge to be supported properly at the abutments. As discussed in Section 9.4.3, the bridge was structurally evaluated for this new, longer configuration. We also evaluated a separate option where an additional section was added at each interior splice thus lengthening the bridge; however this option would increase the loadings in the truss web members beyond their design capacity which would result in increased member replacement and cost.

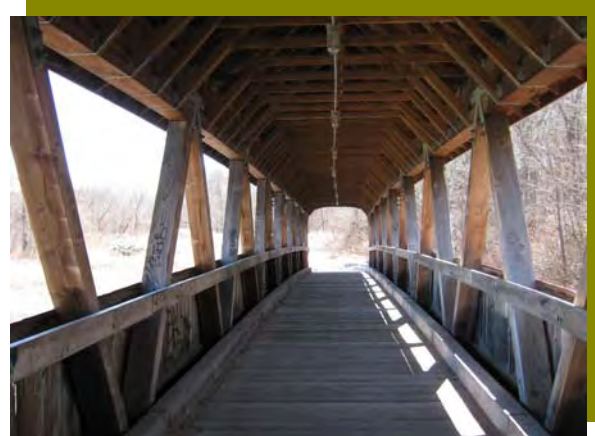
Inside of Dover Covered Bridge

The DCB is generally in good condition with some small areas in poor condition. The lower portions of the bridge have retained varying amounts of sand on top of the lower chord and decking. Especially noticeable inside the bridge is graffiti on the siding and truss members. The graffiti is extensive and extends throughout the length of the bridge. The following observations were also made regarding the condition of the bridge:

- The roof consists of wood shingles on plywood. The shingles are missing in several locations.
- The roof eave trim is painted white with the paint missing or peeling throughout the bridge.
- The bridge contains interior lighting utilizing simple fixtures and also contains small decorative lights along the eave line. The lights were not tested as part of our evaluation.
- The roof framing is in good condition with no distortion or damage noted.
- The bridge siding is ship lapped and in good condition with some boards missing at mid-span and at the truss bearings. The siding is painted red on the outside face with the paint fading or missing throughout the bridge.

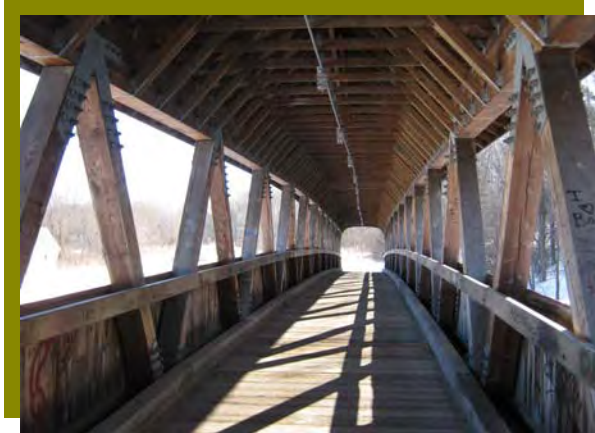
Bridge Trusses

Three vertical load combinations were analyzed for the lengthened bridge per ASCE 7-10. The bridge was reportedly designed for a 7,000 pound vehicle with unknown wheel configuration; however this loading was not evaluated as the intended use of the bridge will be pedestrian. The live load is reduced from 85 PSF used for the floor framing to 65 PSF as allowed by AASHTO for components that have larger tributary areas.

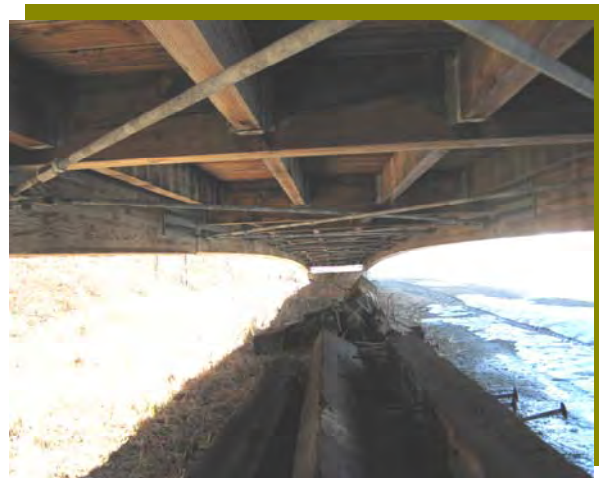
Floor Framing

The floor beams and stringers are pressure treated Douglas Fir members with a grade of No. 1. They were analyzed for dead load and a live load 85 PSF in accordance with the AASHTO Guide Specifications for the Design of Pedestrian Bridges. Due to the smaller tributary area, the 85 PSF live cannot be reduced as is the case with the trusses.

Both the floor beams and stringers were determined to be adequate for these loads.

The connections between the floor beam and trusses are custom galvanized steel plates while the stringer to floor beam connections are pre-fabricated connections. These connections were not evaluated as part of our analysis; however the shop drawings provide design loads for these connections so presumably they are structurally adequate.
